GUANTANAMO
NAVAL STATION
SEWER OUTFALL
INVESTIGATION

BY
T. J. O'BOYLE

FP0-1-81 (13)
JUNE 1981

OCEAN ENGINEERING
AND CONSTRUCTION PROJECT OFFICE
CHESAPEAKE DIVISION
NAVAL FACILITIES ENGINEERING COMMAND
WASHINGTON, D.C. 20374

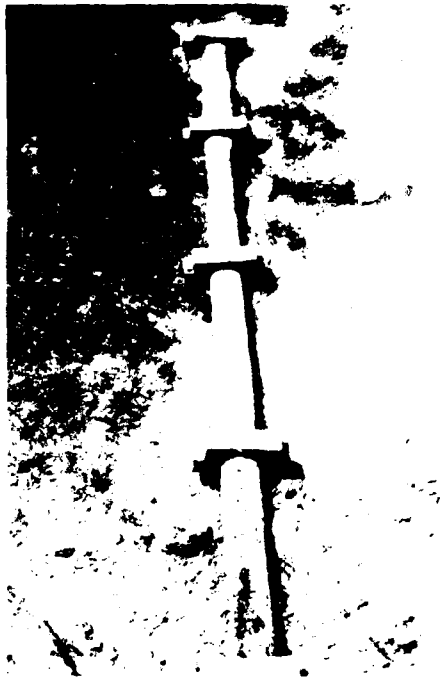
18.	New plastic pipe connection is broken at the C.I. pipe.	No flow evident, could not see end.
19.	Shore end looks good with new plastic pipe added.	End of outfall looks clear.

These two pictures are of outfall No. 19

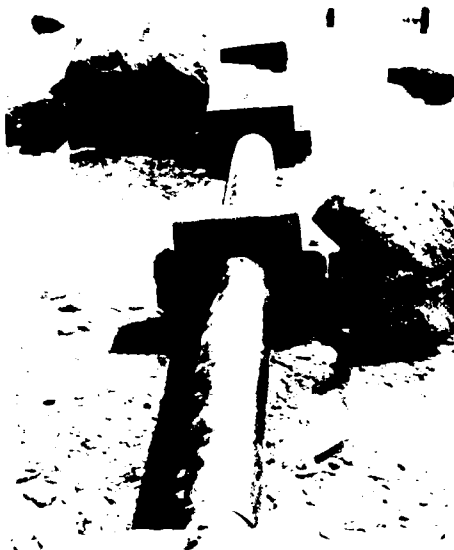
Outfall No. 31
the outfall is intact
